# Why Polysurlyn Moisture Barrier Is a Better Choice Than Polykraft or Painted Moisture Barriers

# Don't Subject Your Valuable Pipe, Tank and Jacketing to the Risk of Corrosion!

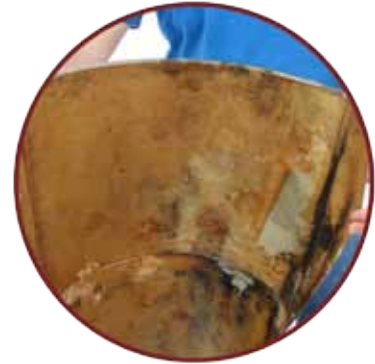
Example of polykraft use that led to corrosion of aluminum jacketing
